JAN KICIŃSKI*

Microbearings and microturbines – possibilities of dynamic state assessment

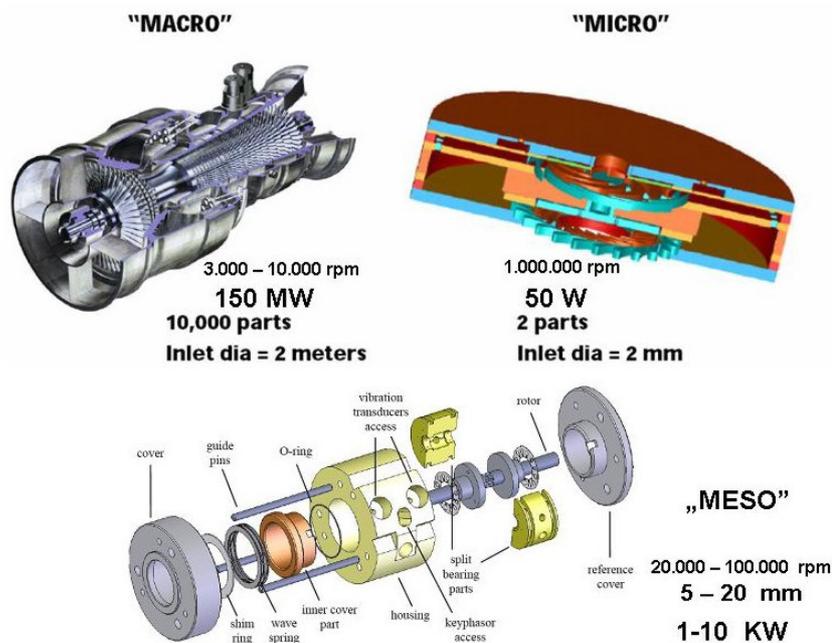
Fig. 1. Tendencies in development of turbines from MACRO through MESO to MICRO scale [2, 3]
 Rys. 1. Tendencje rozwojowe turbin od skali MACRO poprzez MESO do MICRO [2, 3]

A typical configuration of the microturbine rotor shaft (in the mesoscale) is composed of two discs supported by two or three bearings (Fig. 1). Of certain importance is the selection of the (low-boiling) agent flowing through the turbine, which could also be used for lubricating bearings. Here, a selection can be made from among R245fa, R134a, HFE7100, n-butane, isopropanol, toluene, and silicon oil. Selecting the agent depends on numerous factors, most important of which include: the effect on the environment, thermal stability, corrosivity, toxicity, explosiveness, and last but not least, rheological properties. Certainly, microbearings lubricated with such agents work in conditions of a very low

Making use of this rule, let us select for further examination a two-disc three-support rotating machine, in operation in the vibro-diagnostics laboratory owned and operated by IF-FM PAS, Gdansk – Fig. 5 (here, the diameter of bearing journals is equal to $d = 0.1$ m). In the operating conditions selected in such a way that the Sommerfeld number is approximately equal to 0.1, from the dynamic point of view the operation of the research rig rotor can be treated as corresponding to typical microturbine systems in the mesoscale (Fig. 1).

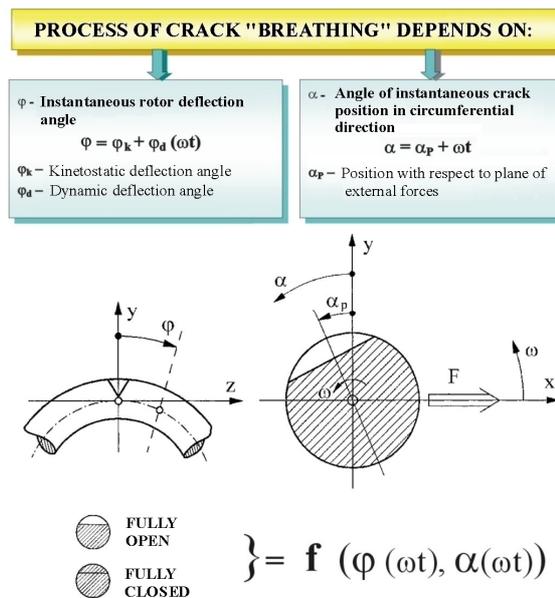
Fig. 2. The adopted concept of rotor shaft crack “breathing” process depending on instantaneous dynamic and kinetostatic positions [1]

What is interesting and novel in the adopted model is a concept of taking into account “breathing” of the shaft crack, depending on the scale of kinetostatic rotor deflections and instantaneous dynamic positions. This is illustratively shown in Figs 2 and 3.

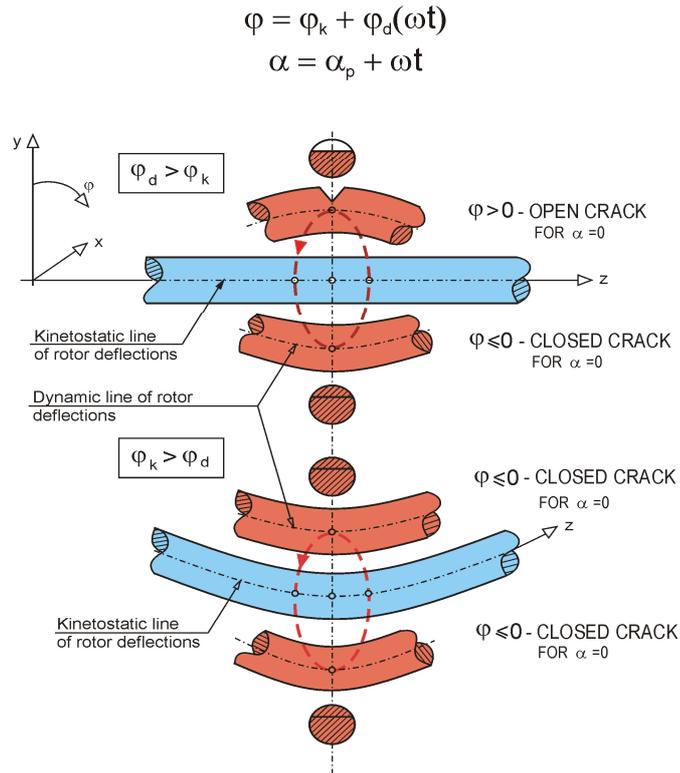
Fig. 3. The effect of kinetostatic rotor deflections on crack "breathing" process [1]
 Rys. 3. Wpływ ugięć kinetostatycznych wirnika na proces "oddychania" pęknięcia [1]

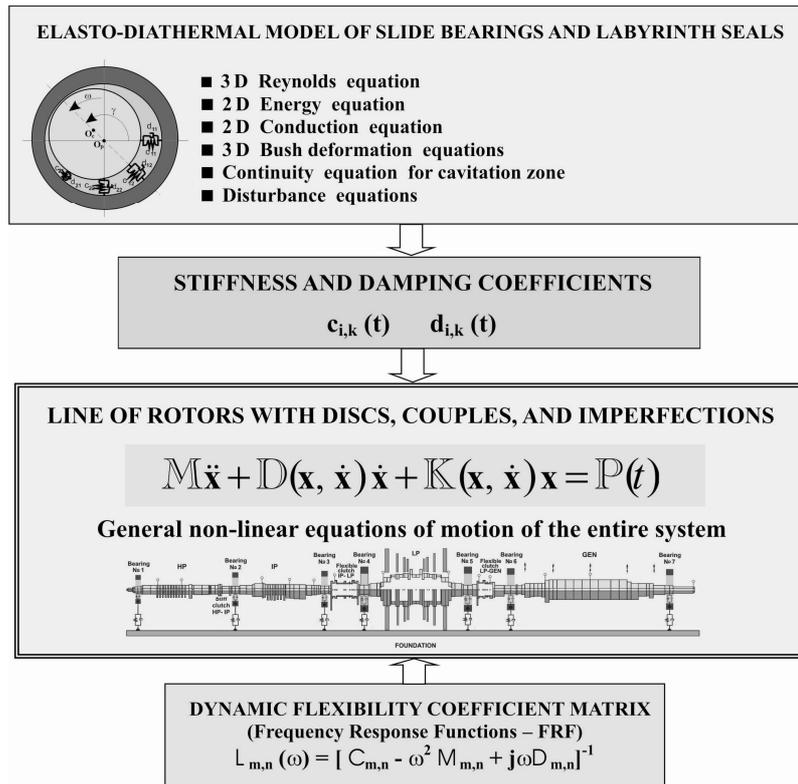
Fig. 4. Time-dependent slide bearing stiffness and damping coefficients, and the supporting structure dynamic flexibility matrices as the elements coupling together the main subsystems of the rotating machine, thus providing opportunities for solving mutually coupled ordinary and partial non-linear differential equations [1]

The most difficult issue in the adopted model is the way in which all sub-systems composing the rotating machine system are combined together into one compatible mathematical and numerical system. This is of special importance for nonlinear modelling, when iterative procedures are to be applied. Here, a concept was adopted according to which, all slide bearing stiffness and damping coefficients and supporting structure dynamic flexibility matrices are modified at each time step of the iterative procedure. As a result we obtain a set of tens of hundreds of nonlinear mutually coupled differential equations, composing the equations of motion for the entire system.

This is illustratively shown in Fig. 4. The method used for searching a solution to the equations of motion and obtaining relevant stability of the numerical solutions is given in the already mentioned monograph [1].

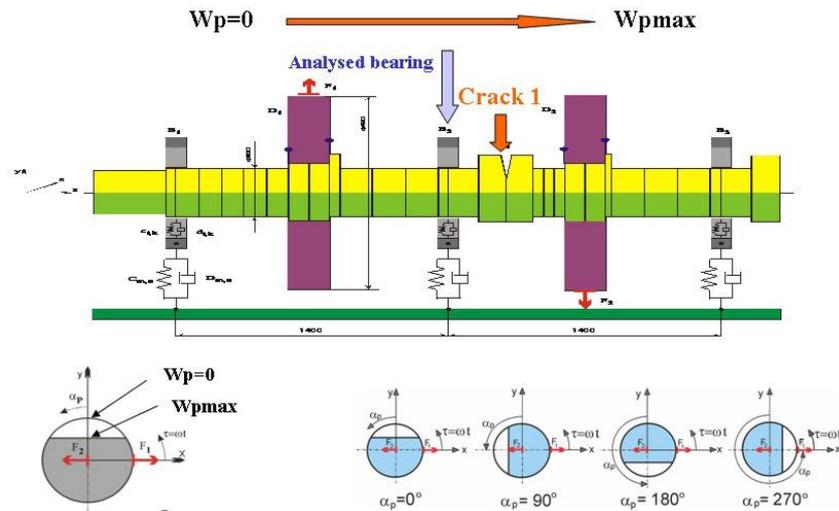
Fig. 5. Object selected for examination: three-support rotating machine with two discs
 Rys. 5. Obiekt przyjęty do analizy. Trójpodporowa maszyna wirnikowa z dwoma tarczami

Let us examine now the effect of rotor shaft crack on the dynamic state of the entire system. Let us assume that the crack is situated in the middle part of the rotor, Fig. 5, and propagates deep into the material, from $W_p = 0$ to the maximum value $W_p = \max$, optionally equal to 20% and 30 % of shaft diameter. The objects selected for examination are “classical” bearing bushes, without thermoelastic deformations, for which the calculated system stability limit is approximately equal to 4700 rpm. Four cases of circumferential position of the

crack with respect to the position of forces making the system vibrate were assumed, Fig. 5, as it turned out in earlier studies that the circumferential position of the crack affects significantly the system vibration pattern. Let us examine the effect of this type of defect in two time instants most dangerous for machine operation, which are: the resonance (here about 2600 rpm) and after the stability limit is exceeded (about 4700 rpm). The results of these examinations are given in Figs 11-13.

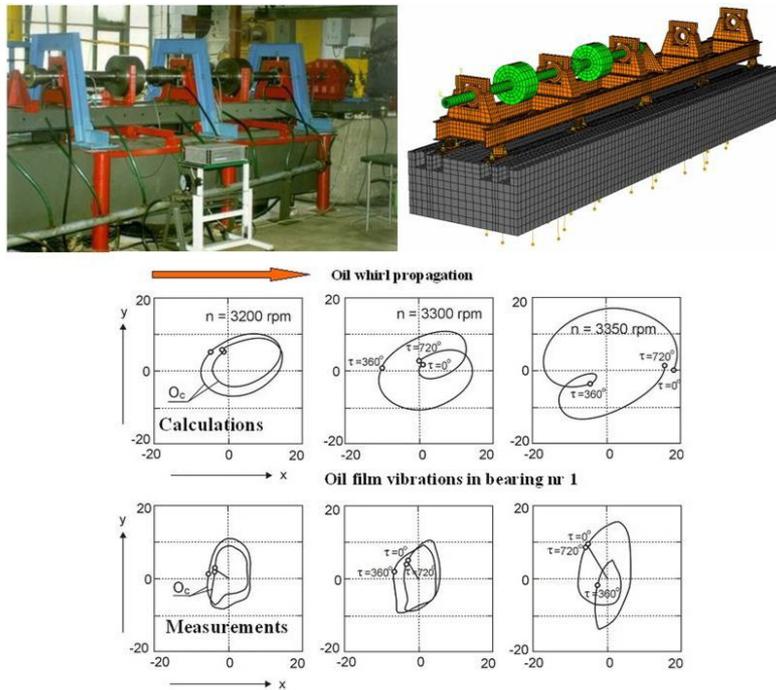
Fig. 6. Sample case of experimental verification of the computer system MESWIR on the research rig (photo taken in the IF-FM PAS vibrodiagnostic laboratory).
 Case of development of hydrodynamic instability (whirls)

A sample case of experimental verification of the computer system MESWIR is shown in Fig. 6. It is noteworthy that this case refers to the verification performed in the situation when the system loses its stability. This type of examination is extremely difficult and dangerous. Taking this into account, the obtained agreement between theoretical and experimental results can be considered fully satisfactory.

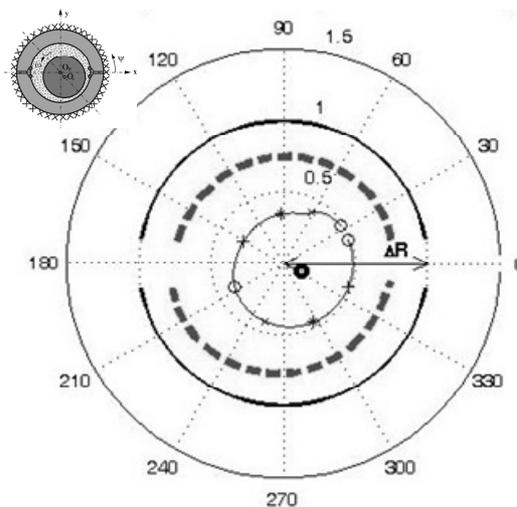
Fig. 7. Bush deformation (broken line) and journal trajectory (after exceeding the stability limit – continuous line – whipping of lubricating liquid – $N = 6350$ rpm) for rigid external bush fixing
 Rys. 7. Deformacja panwi (linia czerwona przerywana) i trajektoria czopa (po przekroczeniu granicy stabilności – linia ciągła niebieska – bicie płynu smarnego – $N = 6350$ obr/min) dla sztywnego utwierdzenia zewnętrznego panwi

Examining dynamic characteristics of the system with the aid of the computer system MESWIR has revealed that for the assumed operating conditions and geometry of the microturbine the stability limits for the bearing fixing case 1 and 2 were approximately equal to 5470 rpm and 5030 rpm, respectively. Figures 7 and 8 present thermoelastic deformations of the inner surfaces of the bush, calculated for the both cases of fixing of outer bearing surfaces. These deformations were confronted with bearing journal displacement trajectories, calculated for rotor rotational speed equal to $N = 6350$ rpm, i.e. after the system stability limit has been exceeded. For the both cases of fixing this speed meant that the lubricating liquid was already in a dangerous phase of whipping, i.e. which meant high hydrodynamic instability. Such a situation undoubtedly creates conditions for real vibroacoustic threats for the entire examined system.

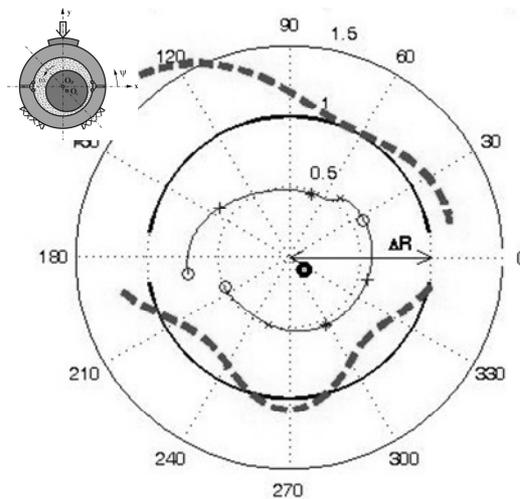
Fig. 8. Bush deformation (broken line) and journal trajectory (after exceeding the stability limit – continuous line – whipping of lubricating liquid – $N=6350$ rpm) for partial bush fixing with preliminary clamp

It is noteworthy that the way of bush fixing has no real effect on the course of whipping of the lubricating liquid, despite very large thermoelastic deformations of the bush, which in some places exceeded 70 % of the nominal design clearance – Fig. 8. For the both cases of bush fixing this state of machine operation is equally dangerous.

The above result can seem a bit surprising, as the engineering intuition suggests that the operating shape of the lubricating clearance similar to that shown in Fig. 8 should improve dynamic characteristics of the system, due to the presence of a small pit in the middle part of the lower bush which stabilises vibrations. But in fact, it is quite opposite, which means that the problem of optimal selection of a shape for the lubricating clearance during bearing operation is much more complicated and each time requires individual assessment of the situation using relevant research tools.

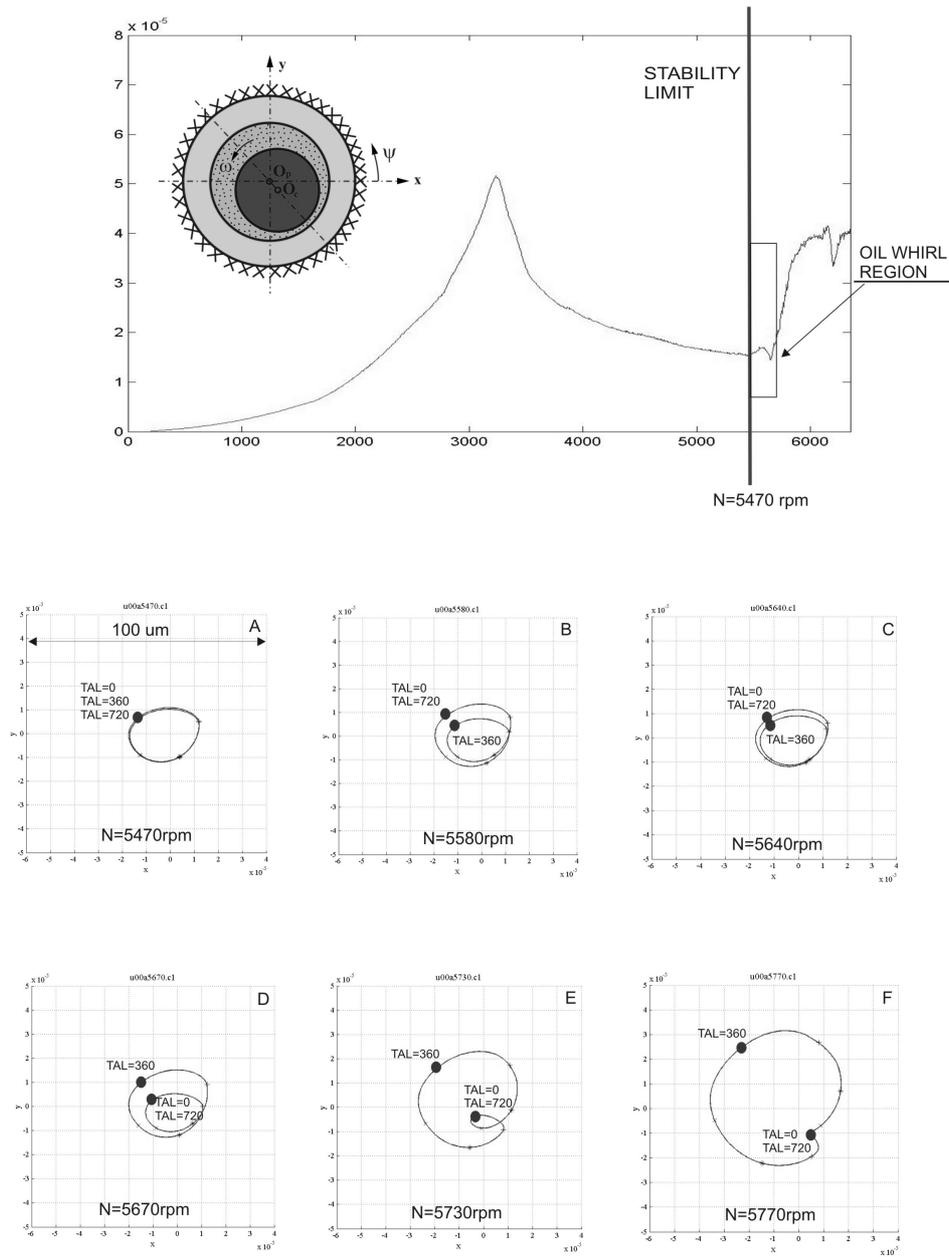
Fig. 9. Development of whirls in lubricating liquid after exceeding stability limit for rigid bush fixing

hydrodynamic instability to such a negligible extent as for the whipping phase? Answers to these questions can be found in Figs 9 and 10.

But a question can be raised whether a similar situation takes place directly after the stability limit is exceeded, i.e. in the conditions of small hydrodynamic instability. In this case we observe the phase of so called whirls created in the lubricating liquid. Does the way of bush fixing affect the course of It has turned out that in this case the effect of the way of bush fixing is definitively much larger. The partial fixing with a clamp is less profitable. The system stability limit appears earlier, and the amplitudes of whirl trajectories are clearly larger.

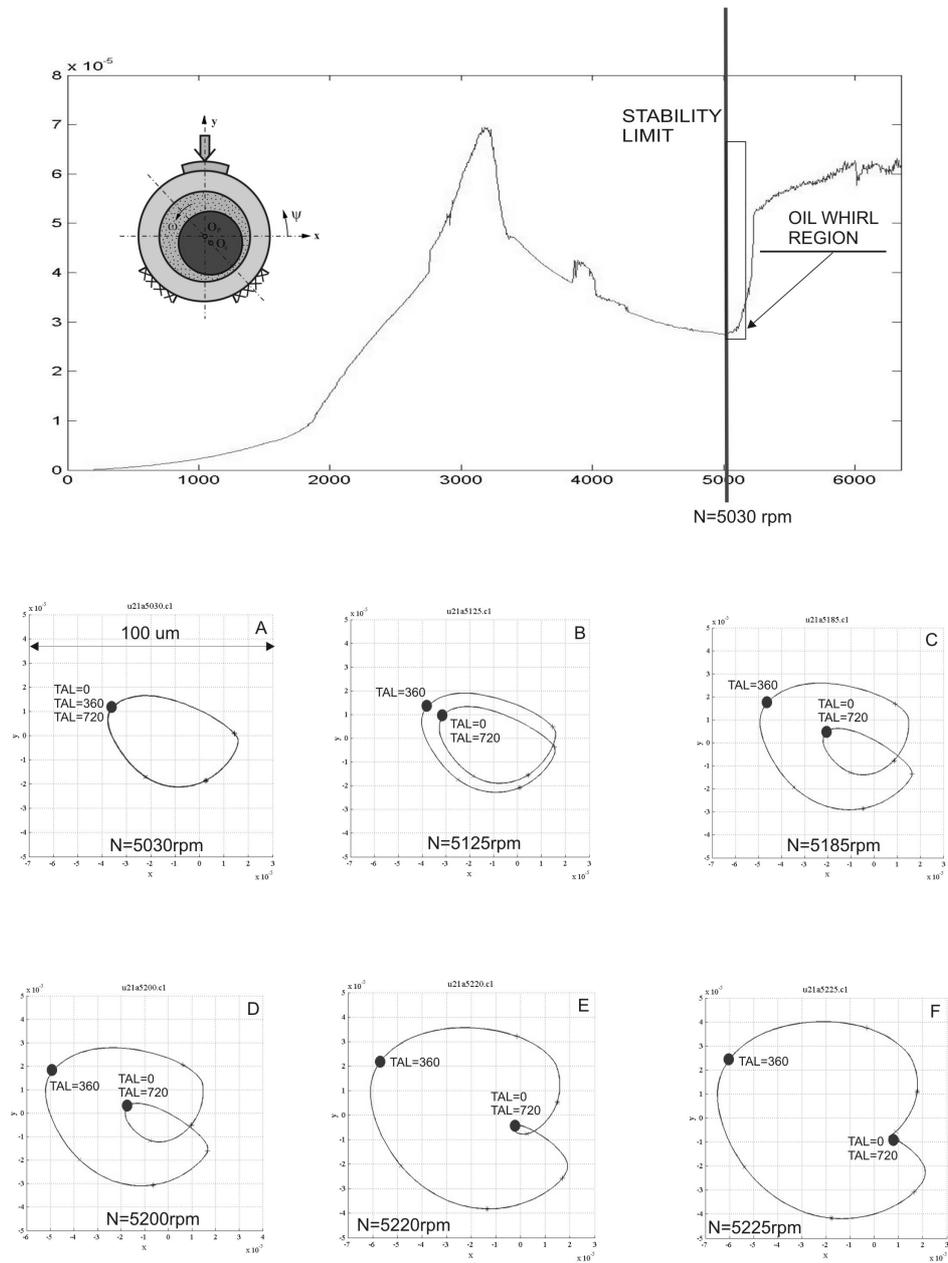
Fig. 10. Development of whirls in lubricating liquid after exceeding stability limit for partial fixing

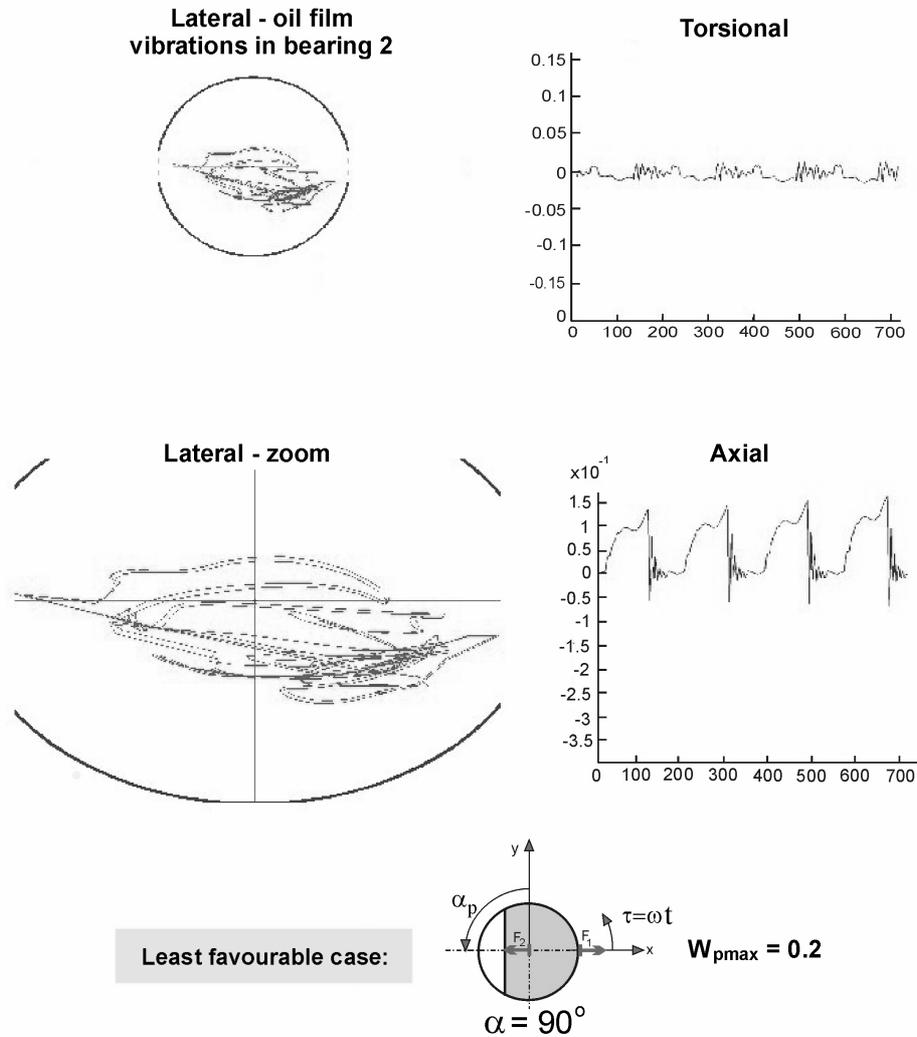
Fig. 11. Coupled vibration forms caused by the crack in resonance range $N = 2600$ rpm (stable range of system operation). Circumferential crack position $\alpha_p = 90^\circ$ – Fig. 5
 Rys. 11. Sprężone formy drgań wywołane pęknięciem w obszarze rezonansowym $N = 2600$ obr/min (stabilny zakres pracy układu) dla obwodowego usytuowania pęknięcia $\alpha_p = 90^\circ$ – rys. 5

For the crack propagation in the resonance, rapid increase of vibration amplitudes is only observed for W_p close to maximum values, i.e. those threatening with dangerous failure. This characteristic is strongly nonlinear. The trajectory patterns for those maximum crack depths are shown in Figs 11 and 12. These figures reveal that the effect of circumferential position of the crack is remarkable. For $\alpha_p=270^\circ$ the crack provoked additional coupled forms of axial, lateral, and torsional vibrations, although the system was not subject to any forces in axial and torsional directions. The observed effect is connected with strong structural nonlinearities generated by the crack in resonance conditions.

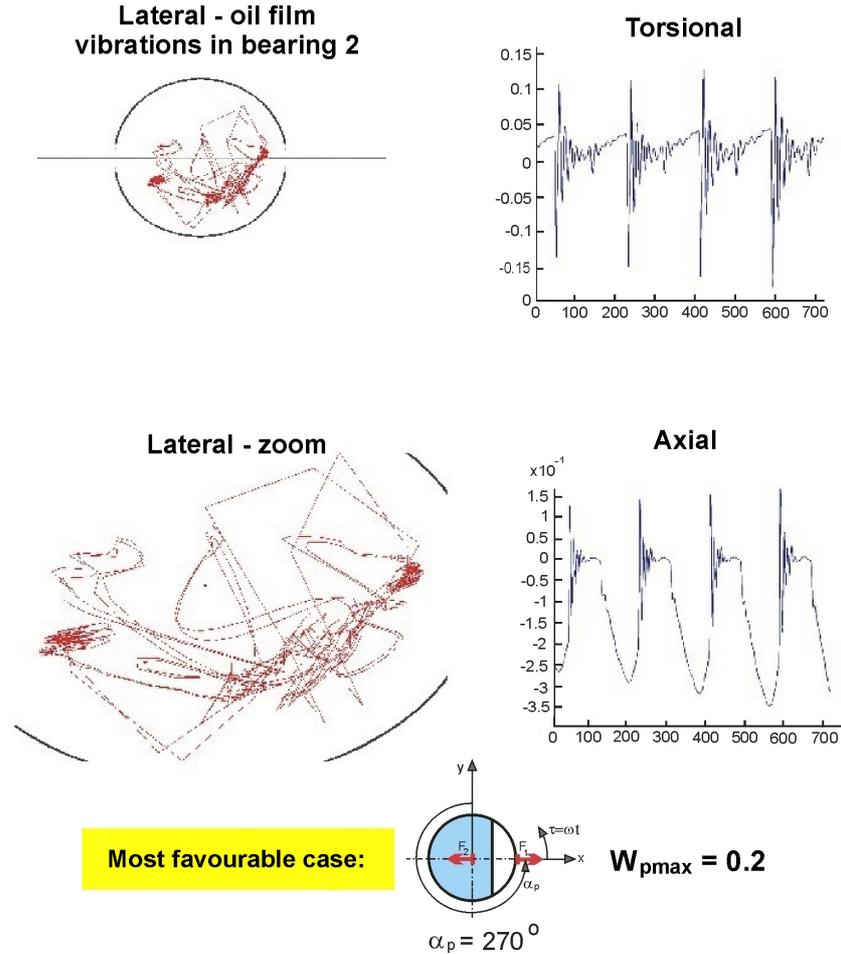
Fig. 12. Coupled vibration forms caused by the crack in resonance range $N=2600$ rpm (stable range of system operation). Circumferential crack position $\alpha_p = 270^\circ$ – Fig. 5

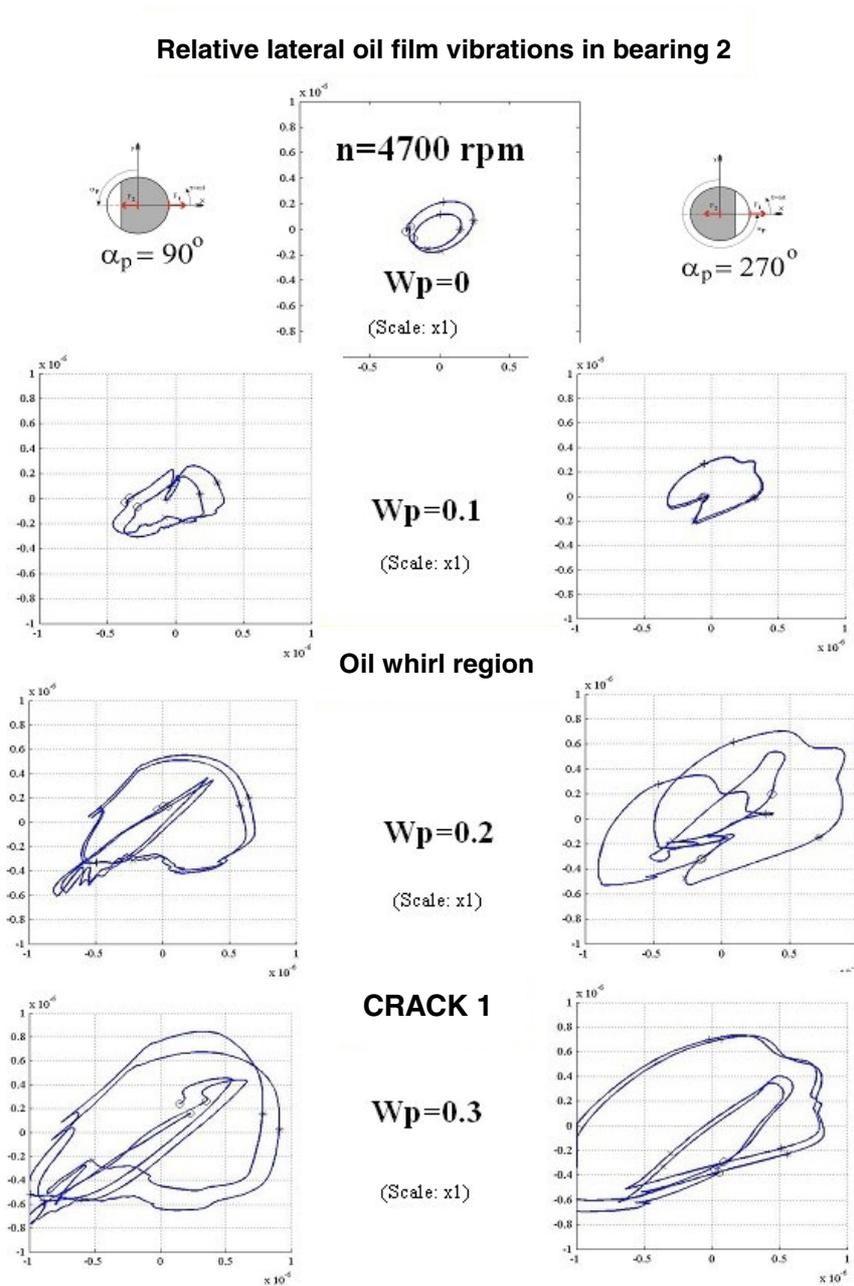
Fig. 13. The effect of rotor shaft crack propagation on the shape of lubricating liquid whirls, for two circumferential crack positions (after exceeding the stability limit $N = 4700$ rpm)

Will the same effect take place in the second critical case of machine operation, i.e. when the stability limit is exceeded? The results shown in Fig. 13 are surprising. The effect of circumferential position of the crack has practically disappeared, and the increase of whirl trajectory amplitude is almost proportional to the depth of the crack. So the course of crack propagation is smoother than expected in this case. This regularity can be explained by the fact that the hydrodynamic instability (whirls) in initial stages of its development generates and supports relatively small amplitudes of bearing journal displacement trajectories. The situation looks different in the resonance and when the whipping of the lubricating liquid takes place. The effect of crack depth increases with the increasing amplitude of system vibrations, irrelevant of the range of machine operation.
